T. TYPHOON ELLEN (050600Z-131800Z DECEMBER 1961)

TYPHOON ELLEN 05-13 DEC 1961
POSITION AND FORECAST VERIFICATION DATA

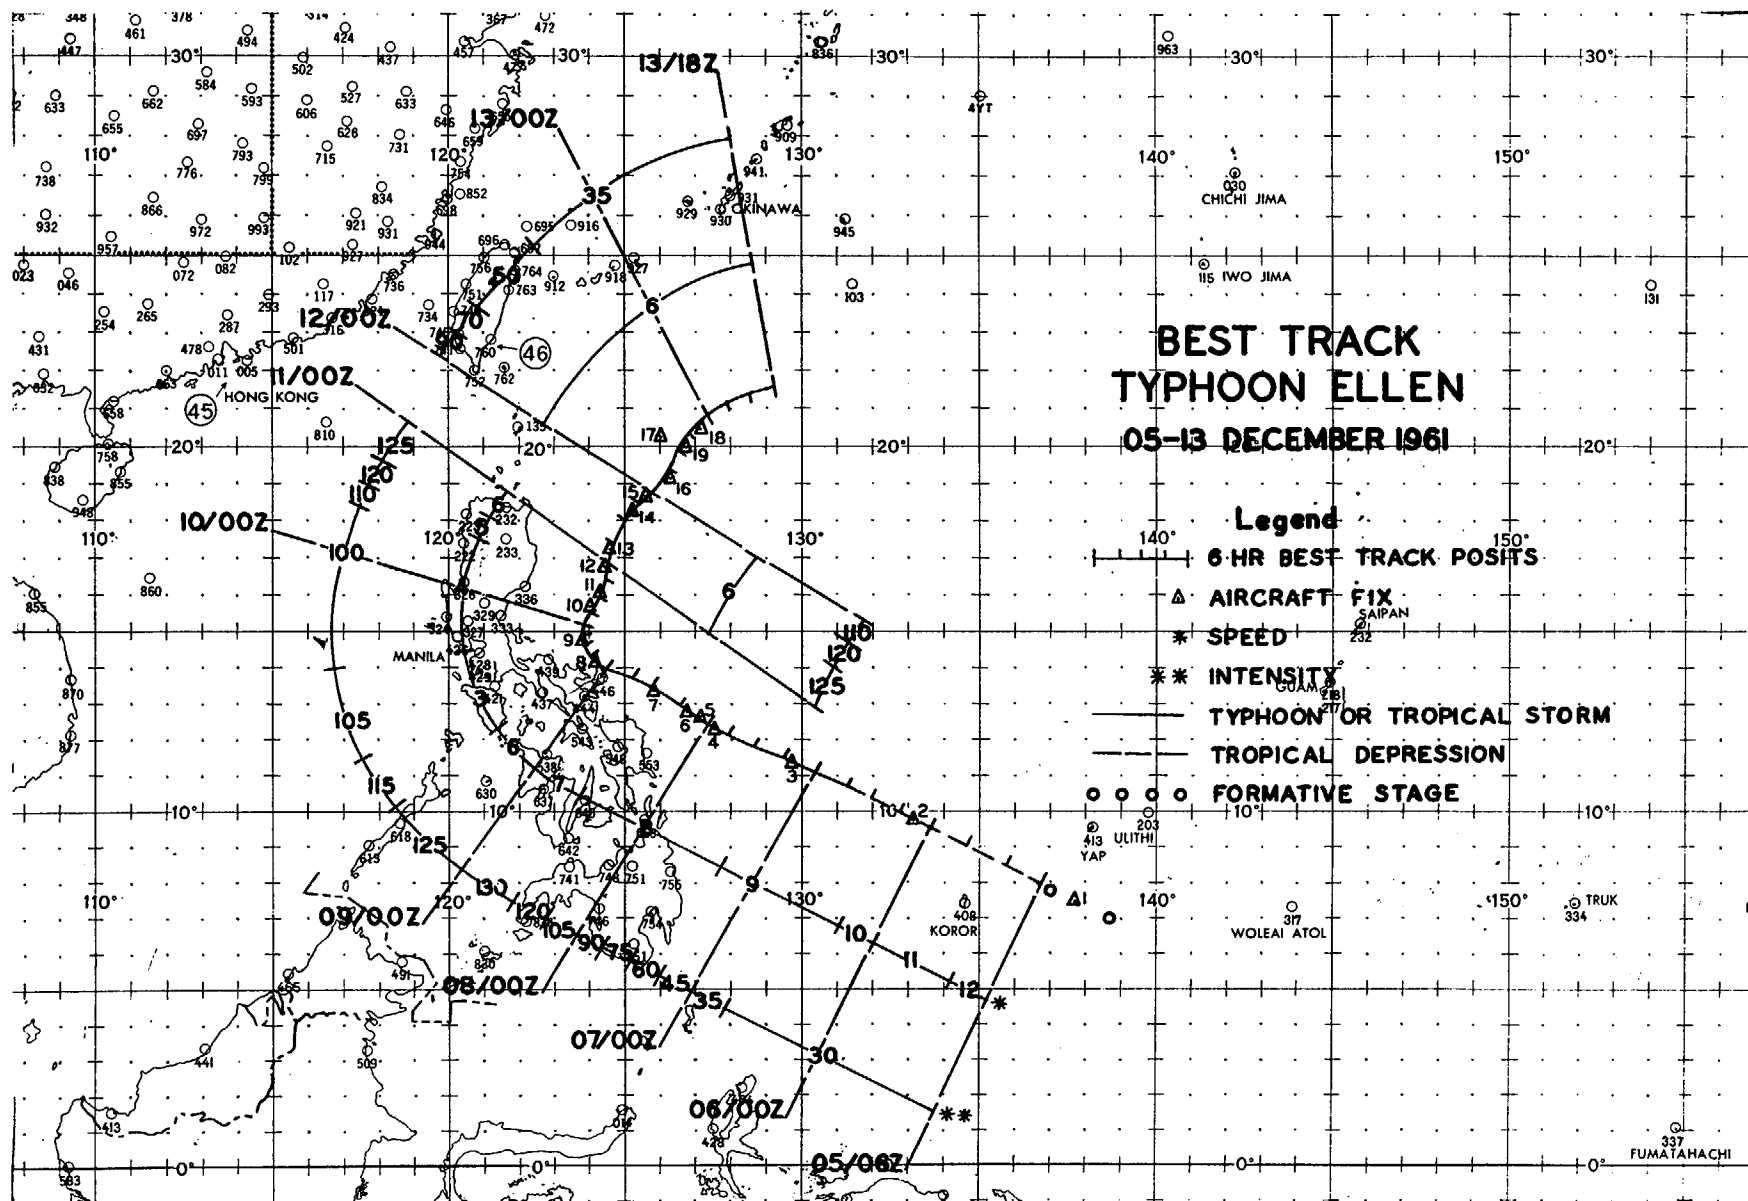
DAMAGE WAS EXTENSIVE, INCLUDING THE ELECTRICAL, WATER AND SEWAGE SYSTEMS, AND NEARLY ALL BUILDINGS AND VEHICLES. THE DAMAGE WAS DUE TO HIGH WINDS, FLYING OBJECTS, FLOODING AND RAIN. IN MANY CASES SEVERAL FEET OF SAND REMAINED BEHIND TO BE REMOVED LATER.
